**RETURNED SOLAR MAX HARDWARE  
DEGRADATION STUDY RESULTS**

Jack J. Triolo  
Gilbert W. Ousley  
Goddard Space Flight Center

## ABSTRACT

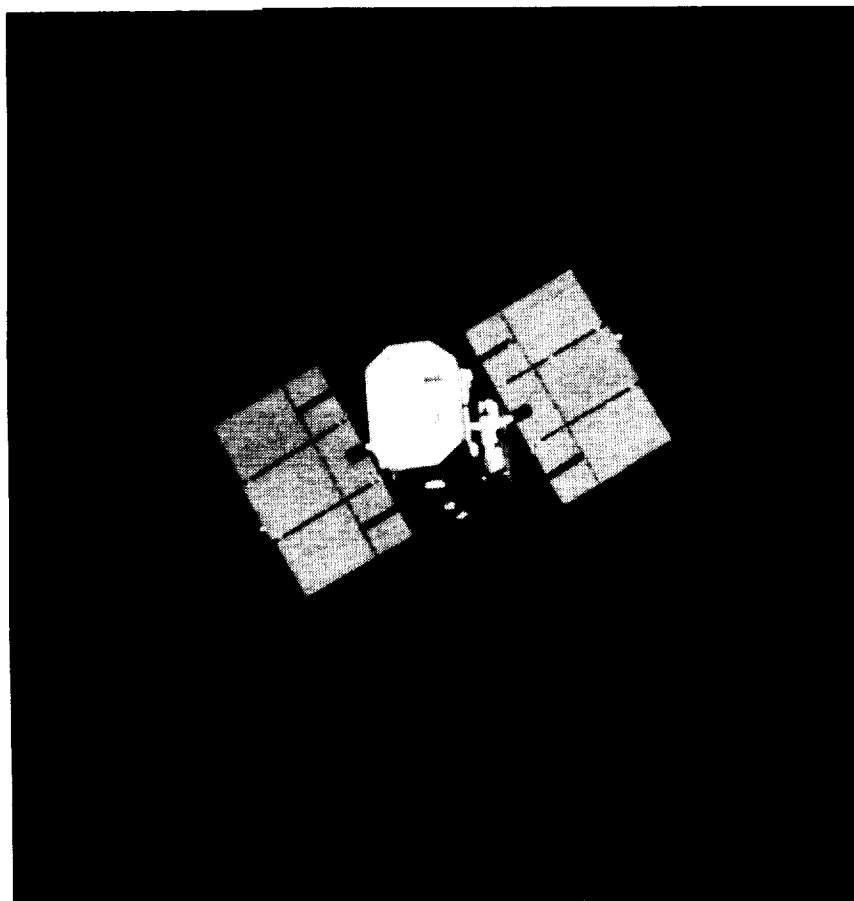
SMM as seen by the Sun in the post-failure attitude ( $15^\circ$  wobble).

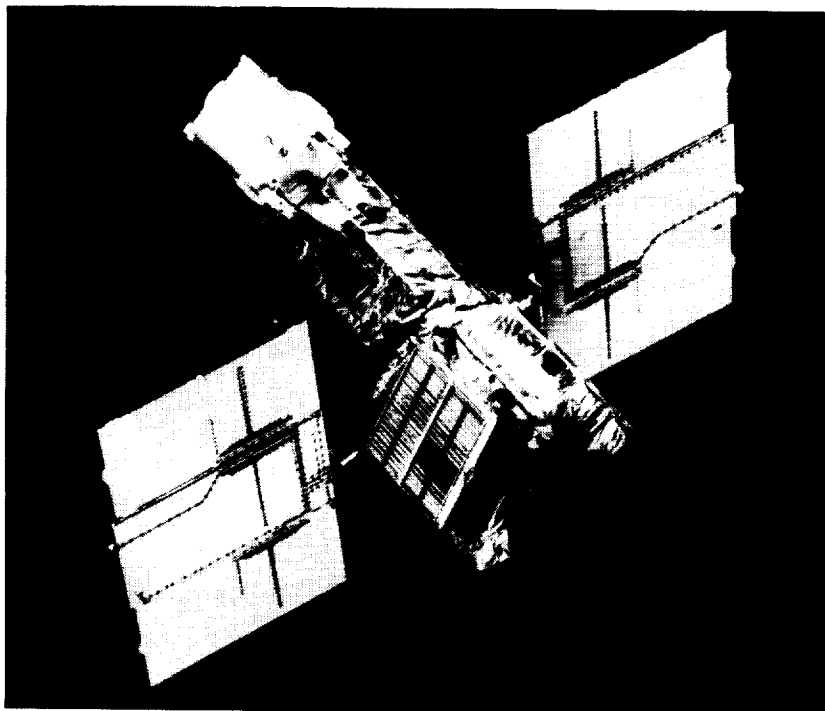
View of MACS module after unsuccessful dock attempt. Most louvers are closed. Degradation of the bottom-facing trim (Teflon) can be seen.

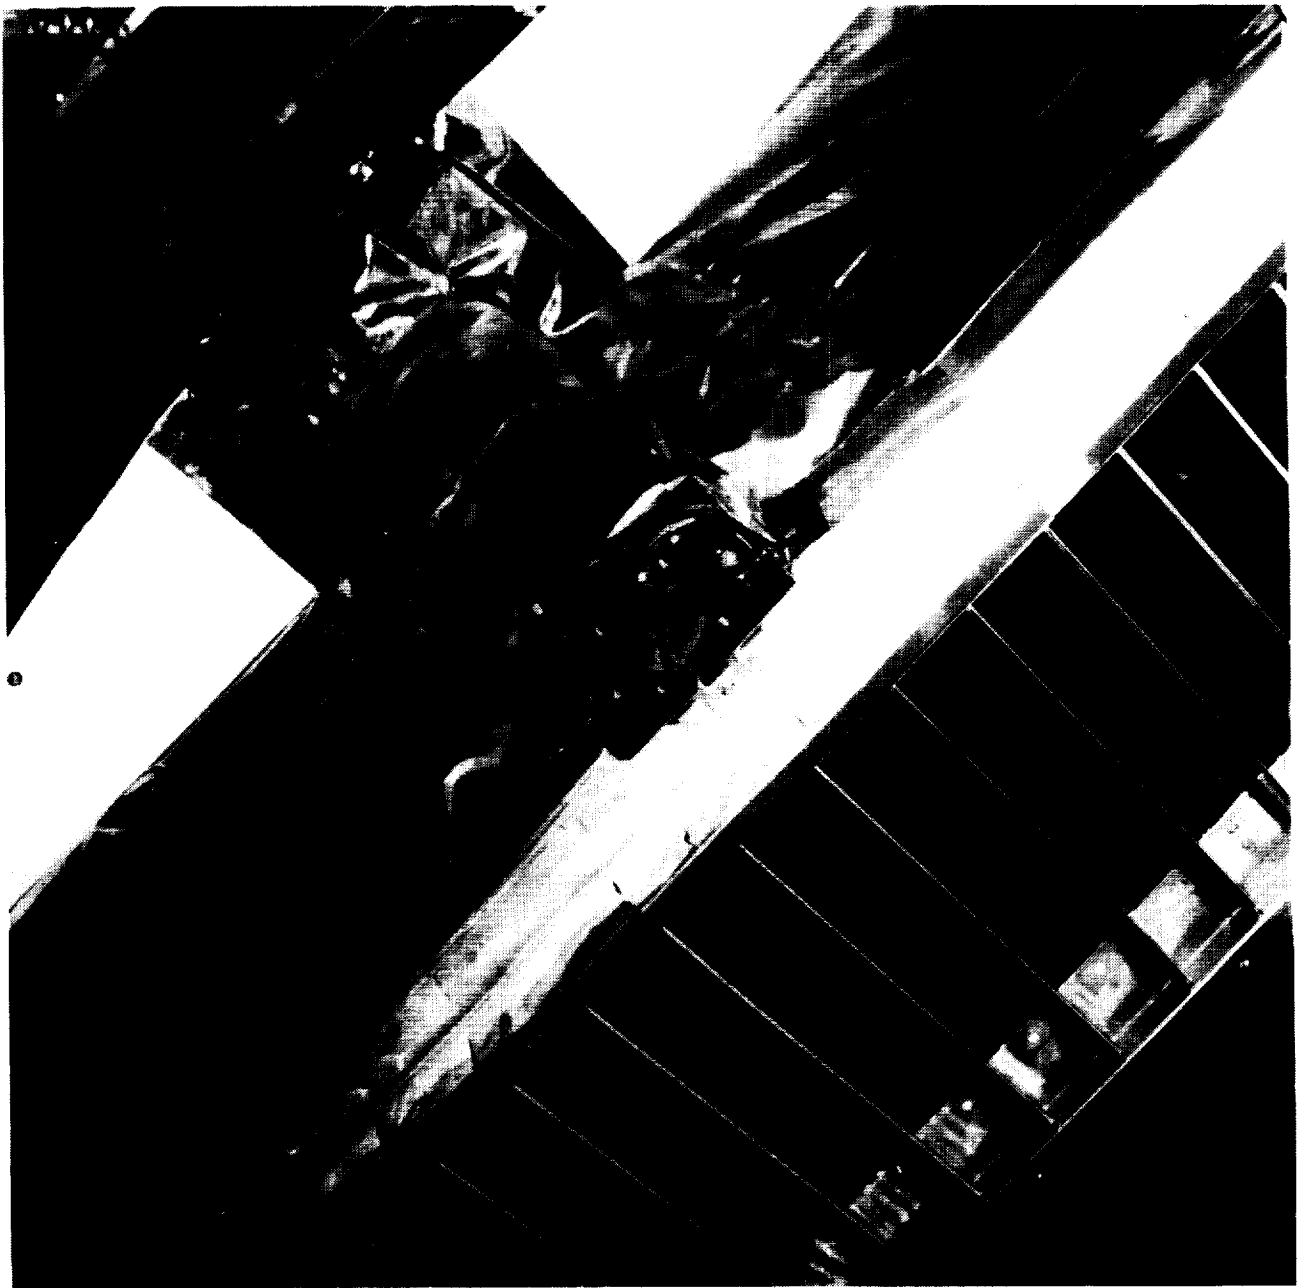
The samples exposed on the silver/Inconel surface also show reaction to the orbit environment. Reactions range from cracks in the Inconel layer to a total depletion of silver and Inconel. In the later case, the exposed Teflon surfaces of some samples have developed the cone structures discussed earlier.

The cracks in the Inconel surface may be due to temperature cycling under varying orbit conditions. Other evidence has indicated that the reaction of Inconel with atomic oxygen causes removal of the Inconel layer. Silver oxide deposits have been found on sample surfaces. The silver oxide may have come to the Inconel surface through the apparent cracks after the exposed silver reacted with atomic oxygen. Exposure tests indicate that the silver/Inconel depletion may be caused by exposure to atomic oxygen alone, or to a combination of atomic oxygen and UV. This suggests a mechanism for the loss of Inconel and silver. First, the atomic oxygen and temperature cycling causes the loss of Inconel and the formation of cracks. Silver oxide (and perhaps silver peroxide) forms and then flakes off in response to temperature cycling. This cycle continues until Teflon is exposed, and the Teflon reacts to atomic oxygen and UV resulting in the formation of the cone structures.

REACTIONS OF UNSUPPORTED SILVER TEFLON  
- THERMAL CYCLING CAUSED CRACKS IN SILVER LAYER  
- NEGLIGIBLE EFFECT ON THERMAL PROPERTIES WHEN SILVER IS NOT EXPOSED  
- SILVER WAS REMOVED BY OXYGEN REACTION WHEN EXPOSED

Close up of the degraded silver Teflon louver trim on the "bottom" side to solar radiation and the atomic oxygen fluence on the silver/Inconel side of the silver Teflon.

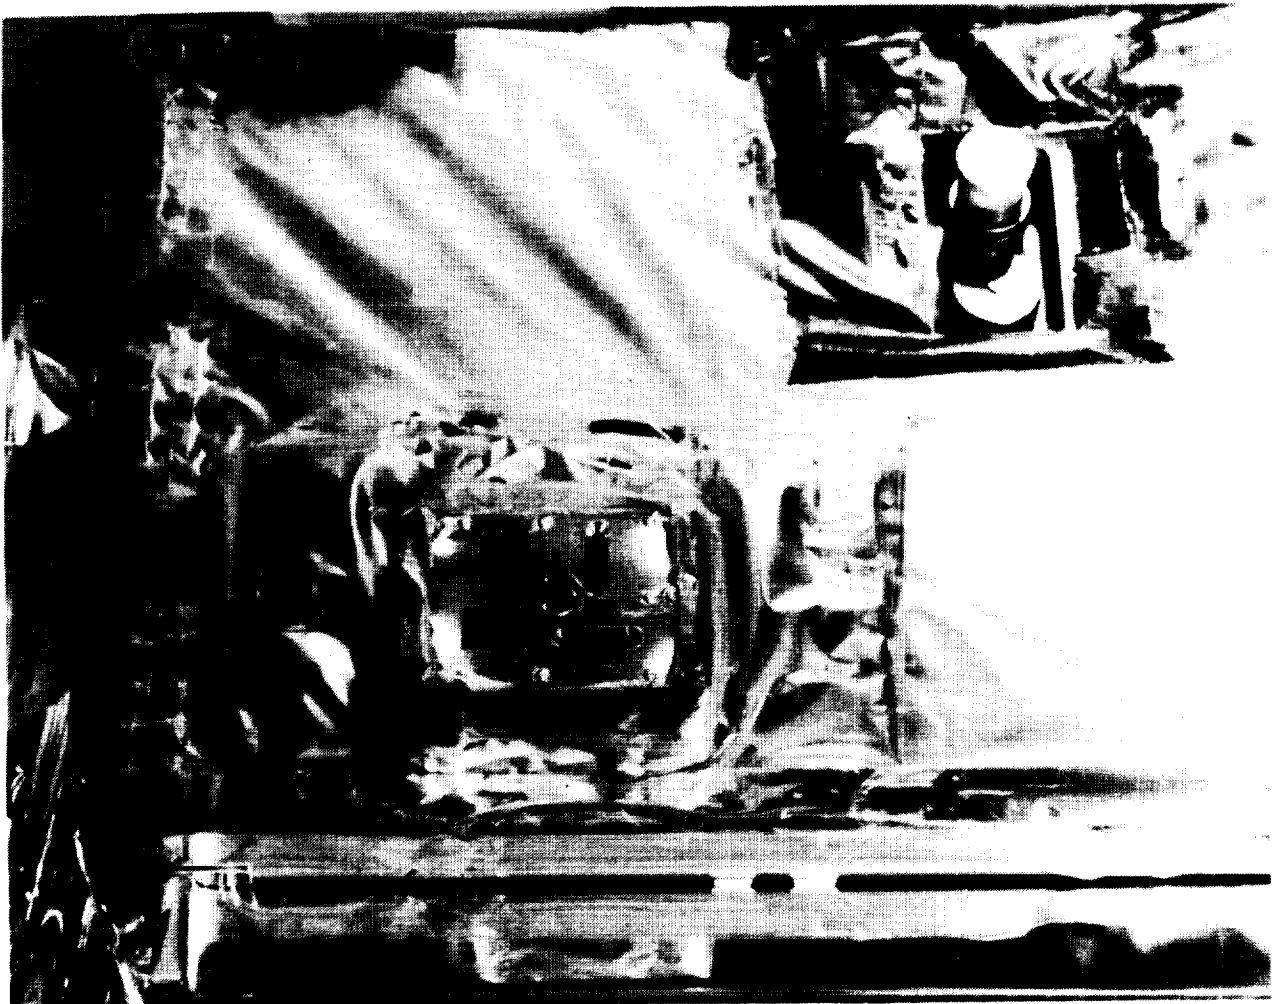
WHITE SUBSTANCE ON FINE SUN SENSOR, COMPOSITION UNKNOWN  
- CONDENSED ON COLD SURFACE FROM WARM INTERIOR OF MODULE

White powder residue from unintentional vent on sun sensor radiator.

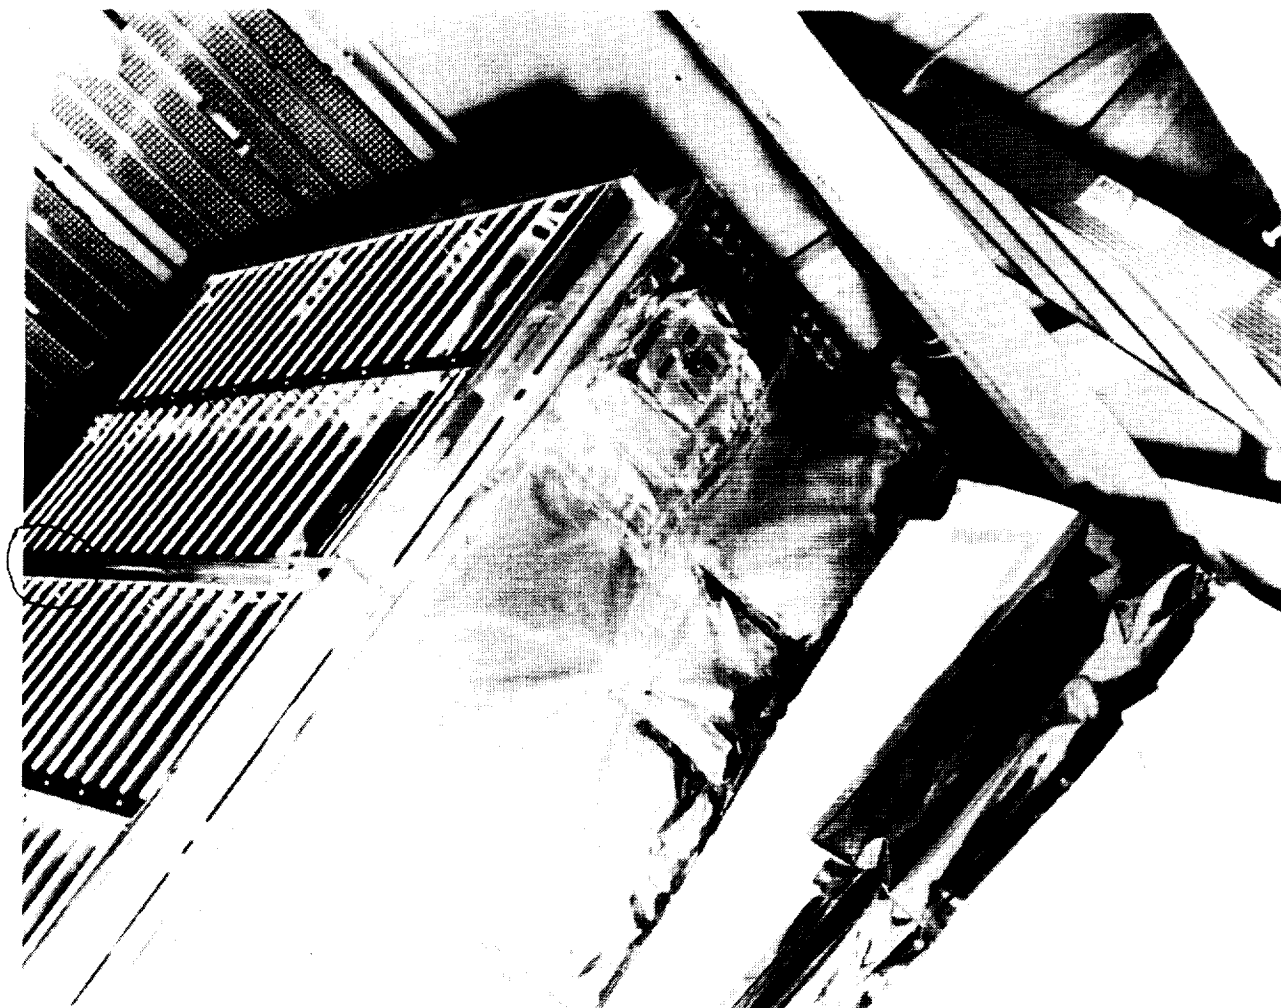
SILICA BASED RESIDUE ON LOUVER FRAME NEAR MODULE VENT  
- OUTGASSING DEPOSIT FROM OIL, THERMAL GREASE, STAKING, ETC.  
- SIMILAR CONDENSATE AROUND VENT BETWEEN STAR TRACKERS

Silica based residue (circled) on louver frame.
